## **APPENDIX E**

### **Site Visit Documentation**

H&A File No.: 33794-000 Date of Visit & Interview: 11-13 September 2006

Site Name and Address: Burgess Pulp Mill, Berlin, New Hampshire

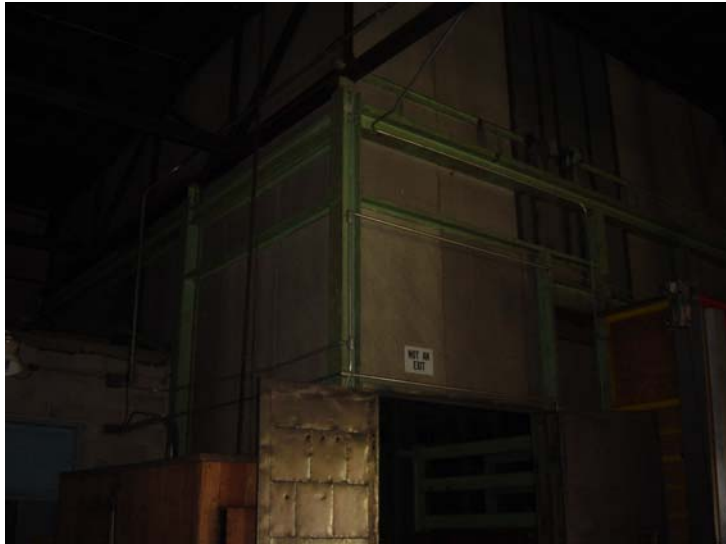
Baled Pulp Storage, Labeled Transite

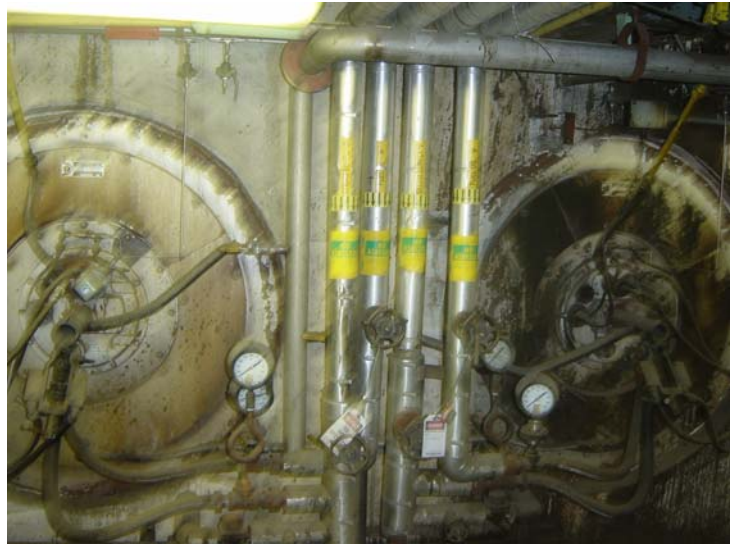
Boiler 9 3rd level, newer work labled non-ACM

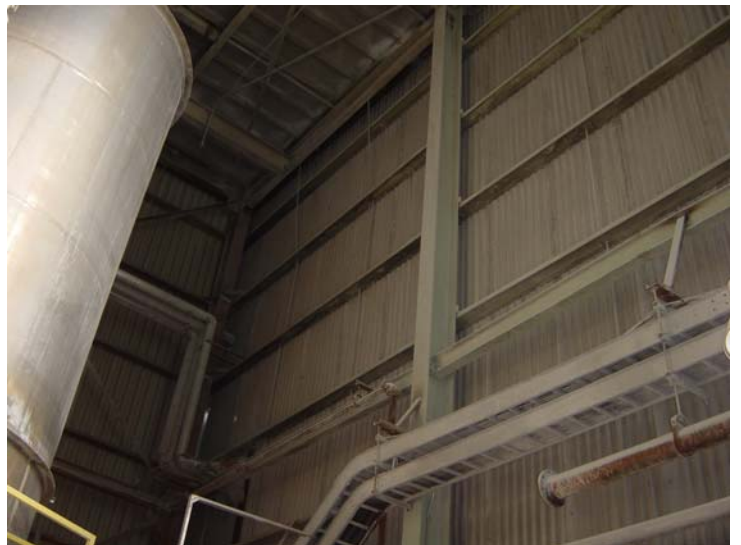
Causticizing Siding Known Transite

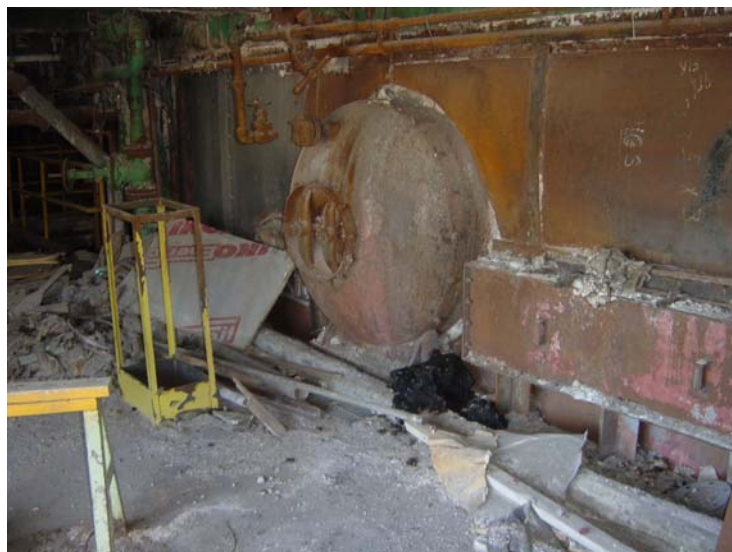
Rec Boiler 8, Upper Level Debris

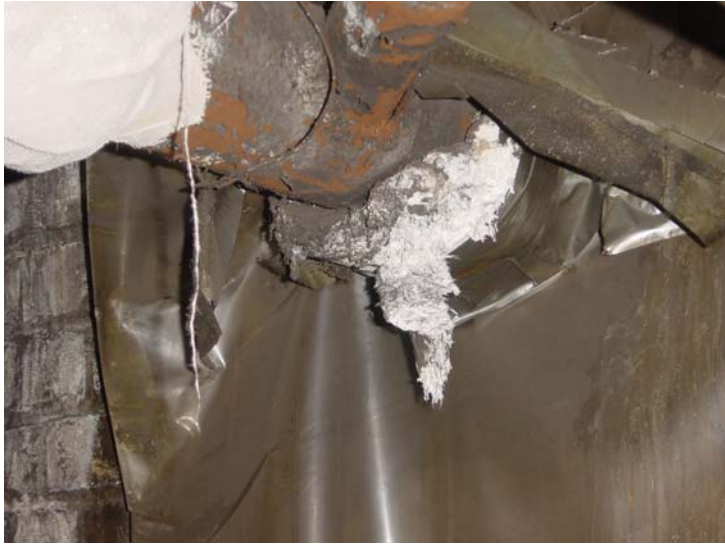
Boiler 9 6th level, dam Pipe TSI

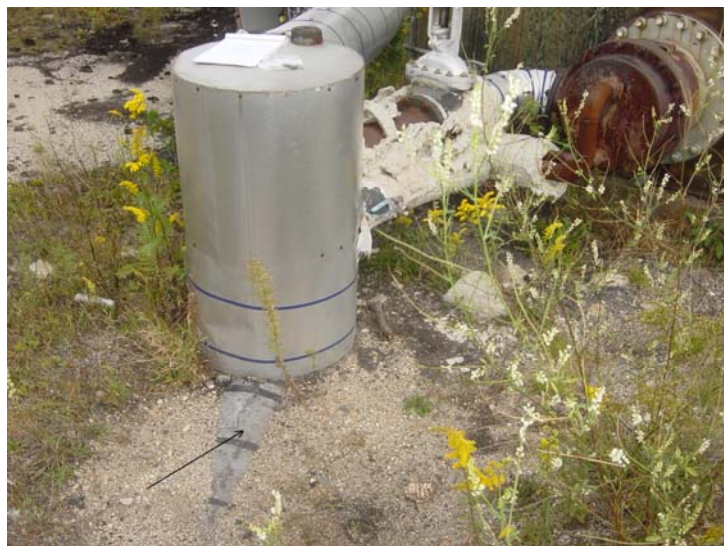
#6 Exterior Oil Tank, Tank Valve, Sample B105 and B106

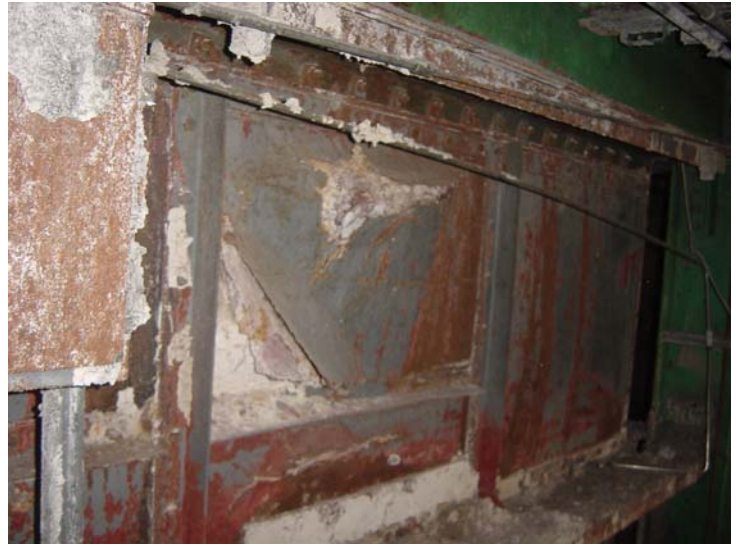
#8 Boiler Recovery Unit, Upper Level, Blow Out Damage, B120

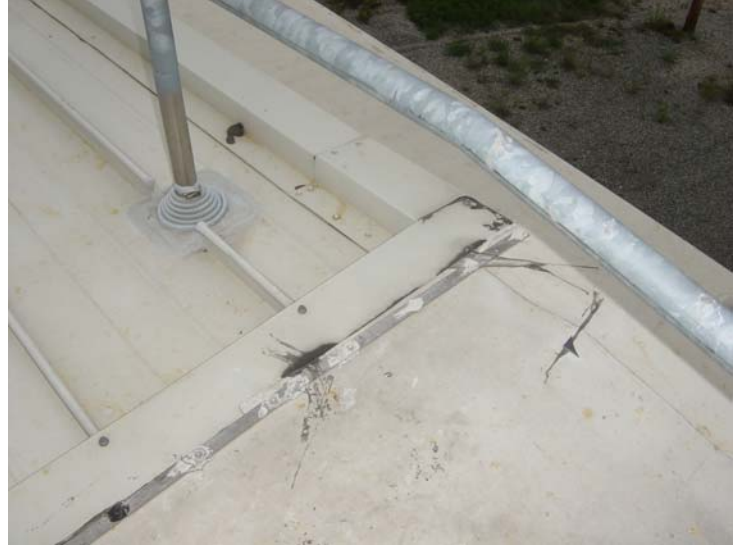
New Co-Gen Plant, Mid Roof, Excess Sealant, Sample B134

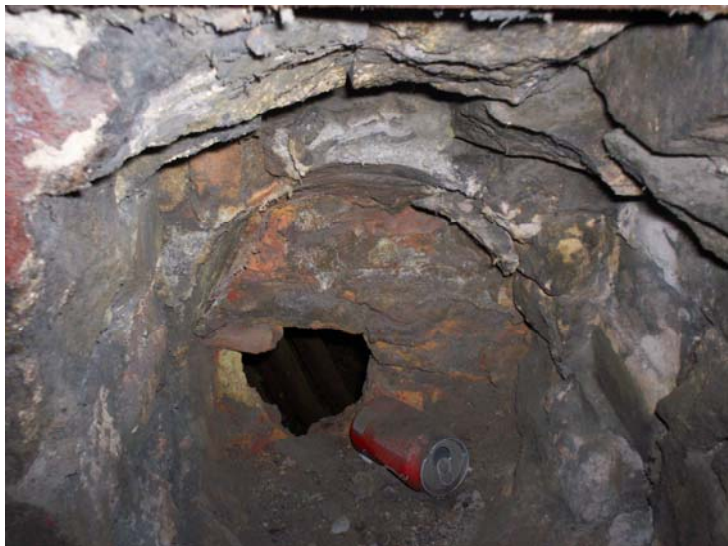
Central Steam Boiler #6 refractory packing, Sample B016

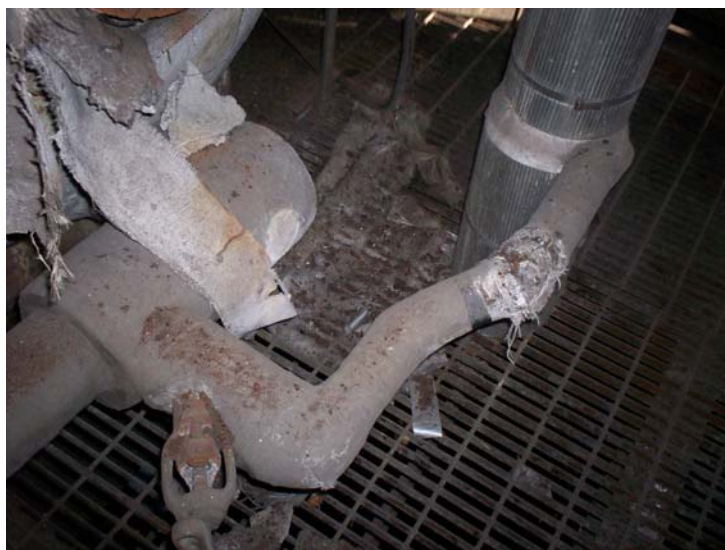
Central Steam Boiler #9 damaged ACBM (not sampled)

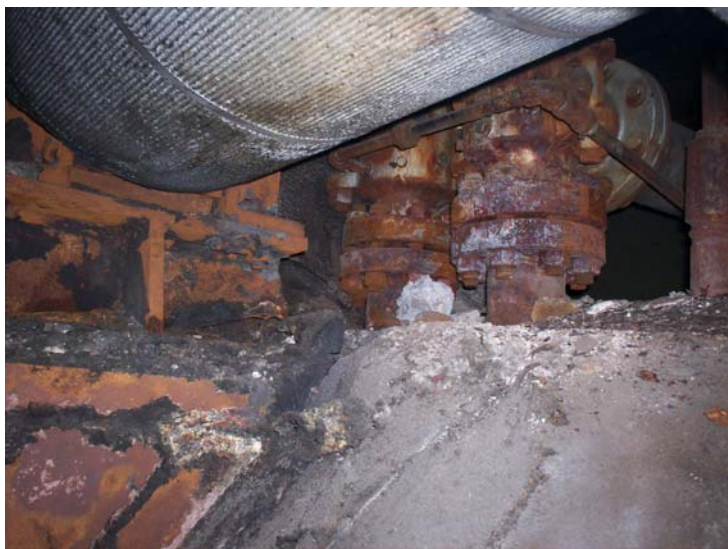
Central Steam Boiler #9 debris 4th level,

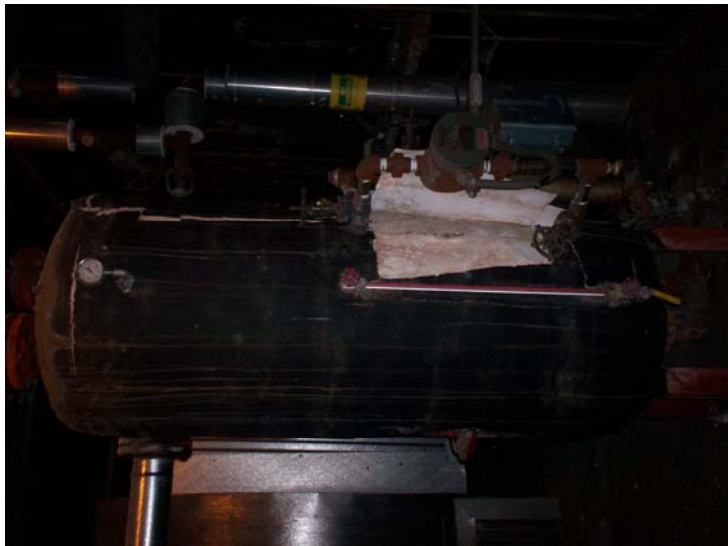
Central Steam Boiler #9 tank insulation damaged (not sampled)

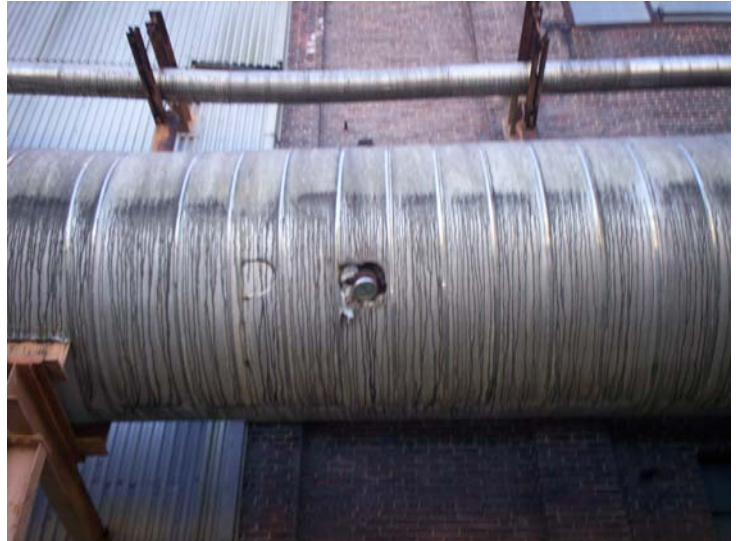
Ext. duct outside Boiler #9, Sample B023 was taken approximately 30' down the duct. It's possible that other suspect material is present in various areas of the duct
